# A Handbook for Earthquake Resistant Construction and Seismic Safety

The Republic of Uganda Ministry of Lands, Housing & Urban Development Kampala

**January**, **2010**

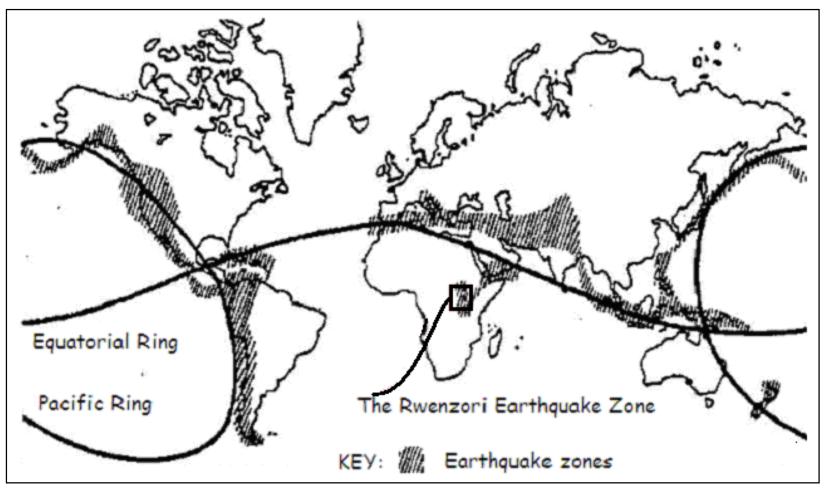
Earthquake zones (Houben, Guillaud 1984)

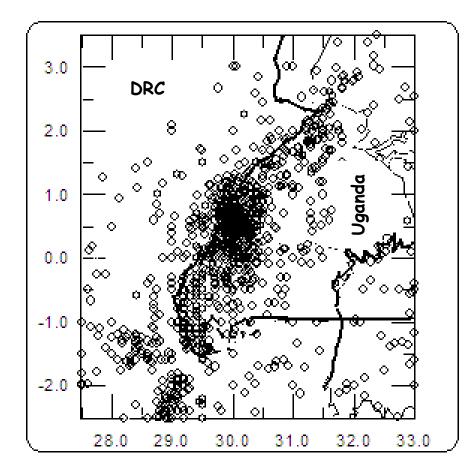
Seismicity in Uganda 1902 - 1999

Each dot represents an earthquake occurrence between 1902 to 1999.

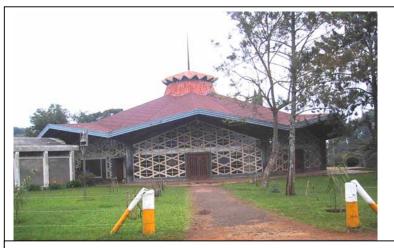
The Catholic Cathedral at Fort Portal rebuilt after the 1966 earthquake to earthquake resistant standards
